# utility aid

*Remote Building Assessment*

*Date: Friday 4<sup>th</sup> November 2022, 2.03pm*

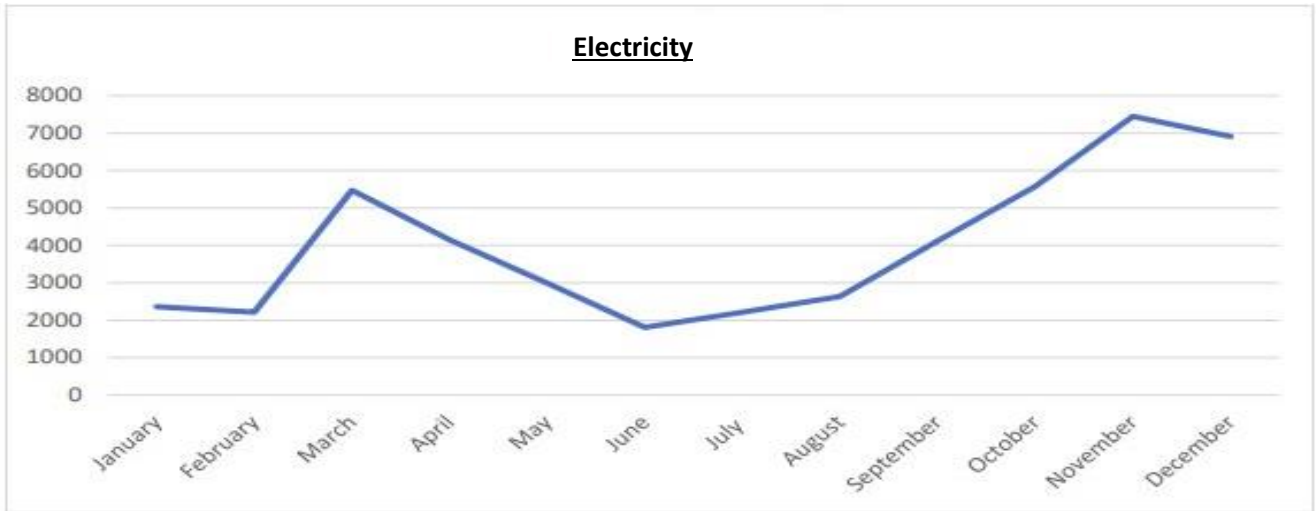
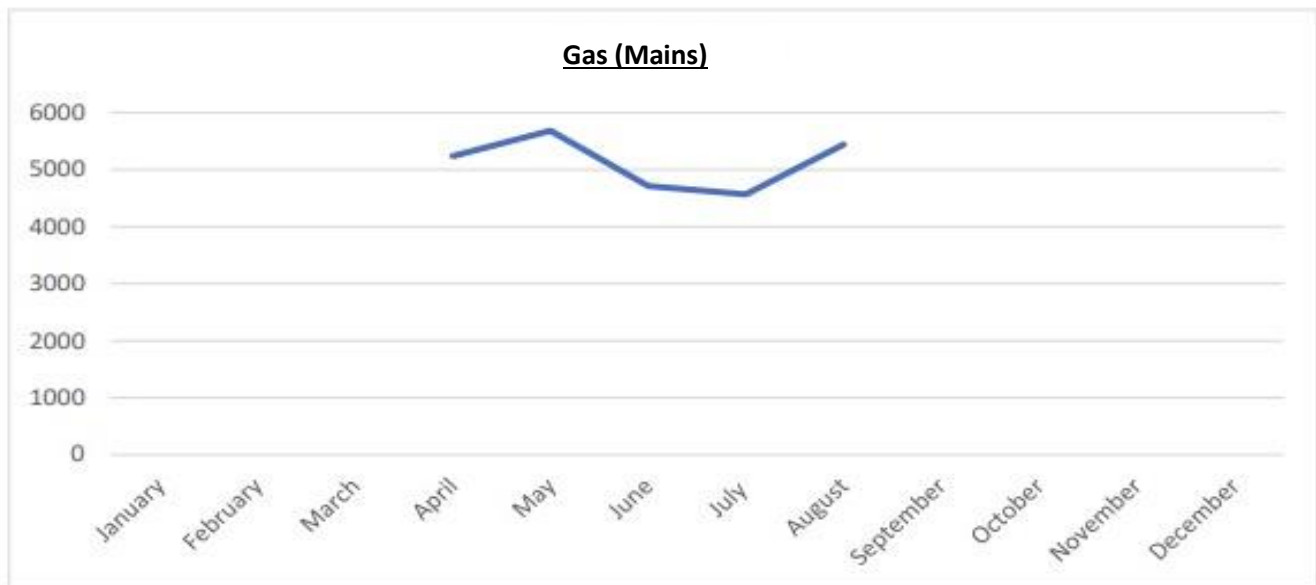
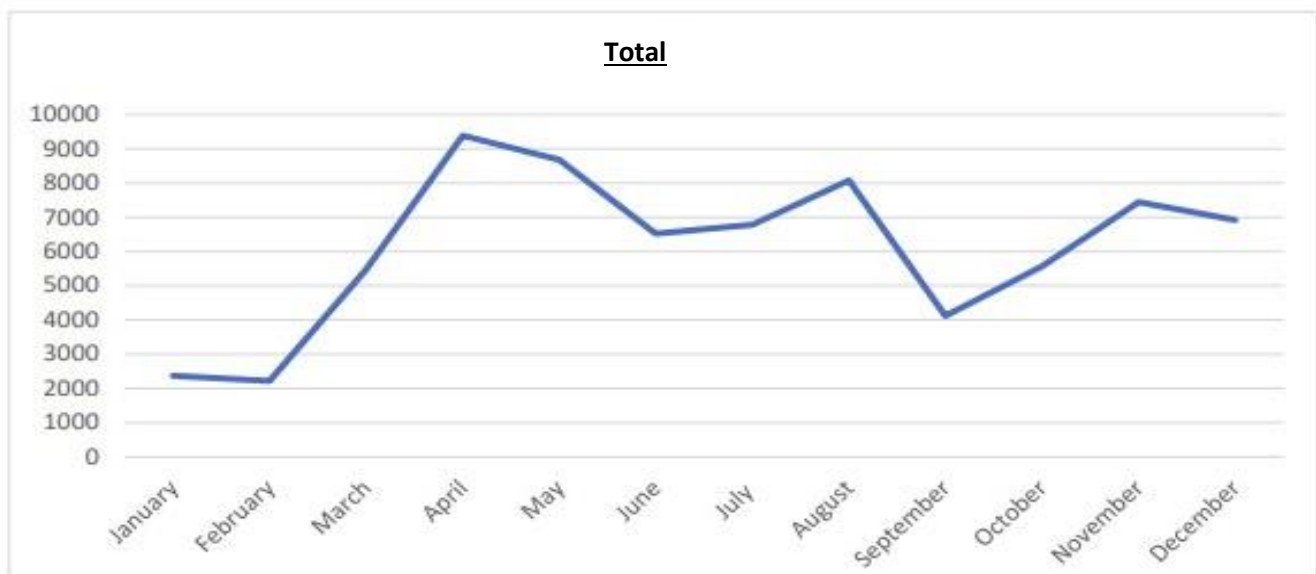
## Monthly Consumption Curves

Monthly Energy Use (kWh)								
	Electricity	Gas (Mains)	Oil	Biomass	Gas (LPG)	Solar PV	Wind	Total
January	2365							2365
February	2218							2218
March	5474							5474
April	4148	5238						9386
May	2994	5682						8676
June	1809	4710						6519
July	2214	4566						6780
August	2635	5439						8074
September	4120							4120
October	5571							5571
November	7449							7449
December	6915							6915
	47912	25635

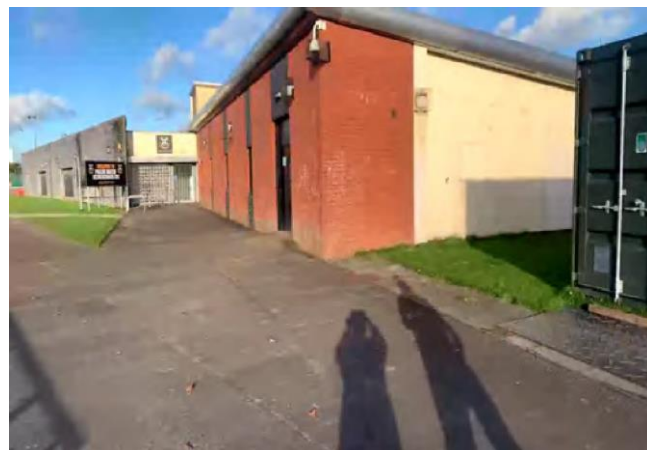
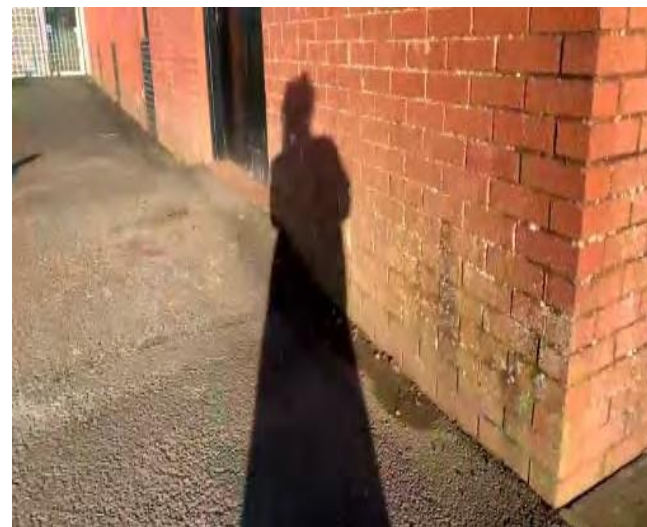
## External Elevations and Building Type

The building at... was reconstructed in the 1990s. The building has a solid ground floor with cavity wall-type construction and industrial roofing panels. The middle part of the building is retained from the original building and is two-story. The section is used as a plant room and is not an occupied part of the premises. The new part of the building is double-glazed and has glass suitable for the purpose of the changing rooms.

Due to the build date, it is probable that the external walls have insulation installed either partially or fully. A bore-scope inspection or access to the architectural drawings is required to confirm this.

The roofing panels will be insulated as per the building specification and have a U value of approx. 0.26wM2.

An assumption has also been made about the floor insulation as there is nothing visible.

8. Obtain building drawings to determine the current level of insulation and expected U Value to determine if the improvement is feasible.
9. Before opening the gym for full-time use, conduct an assessment of ventilation to examine controls and potential for heat recovery

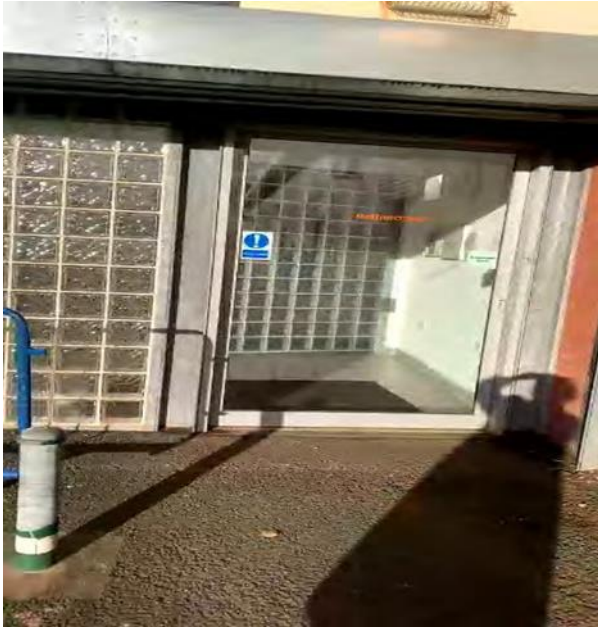
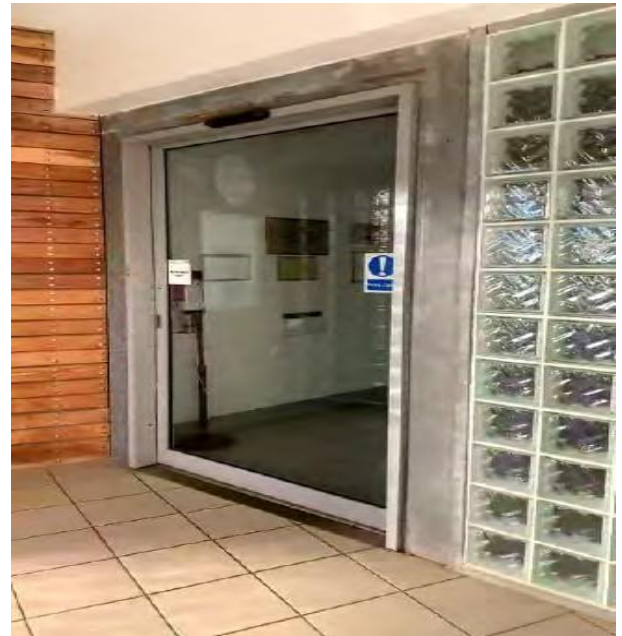
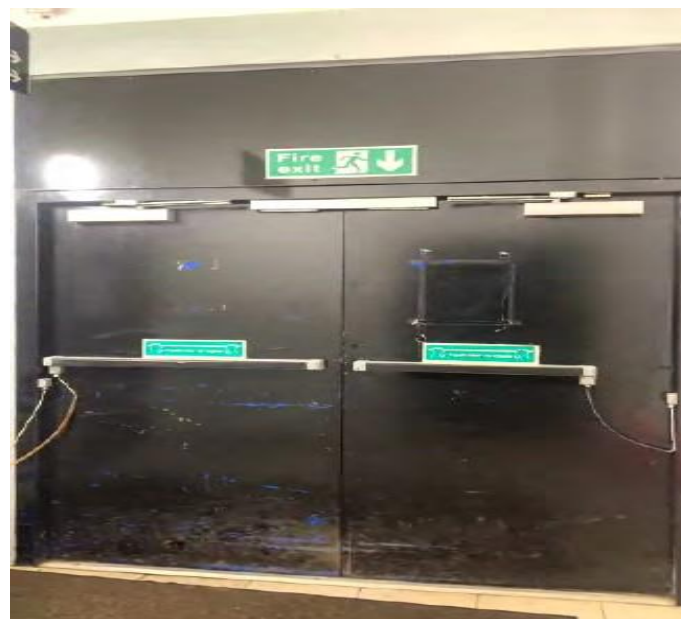
## Windows and Doors

The external doors are double-glazed and automated. There is a double door to minimise heat loss, and the entrance orientation is south, so it should not be a victim of prevailing winds.

The fire doors look appear to be tightly fitted, this area should be checked for drafts on an annual basis with draft-proofing measures fitted where applicable.

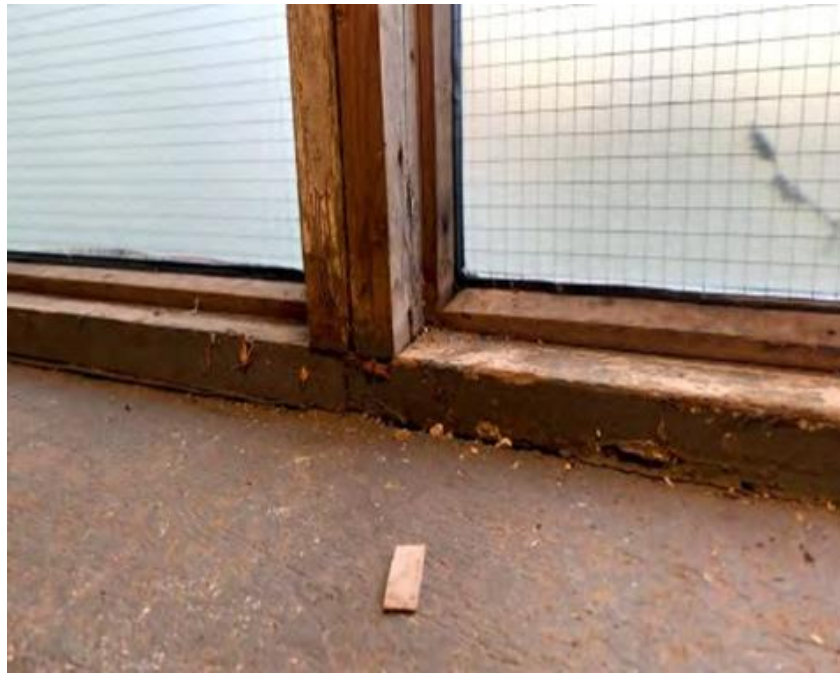
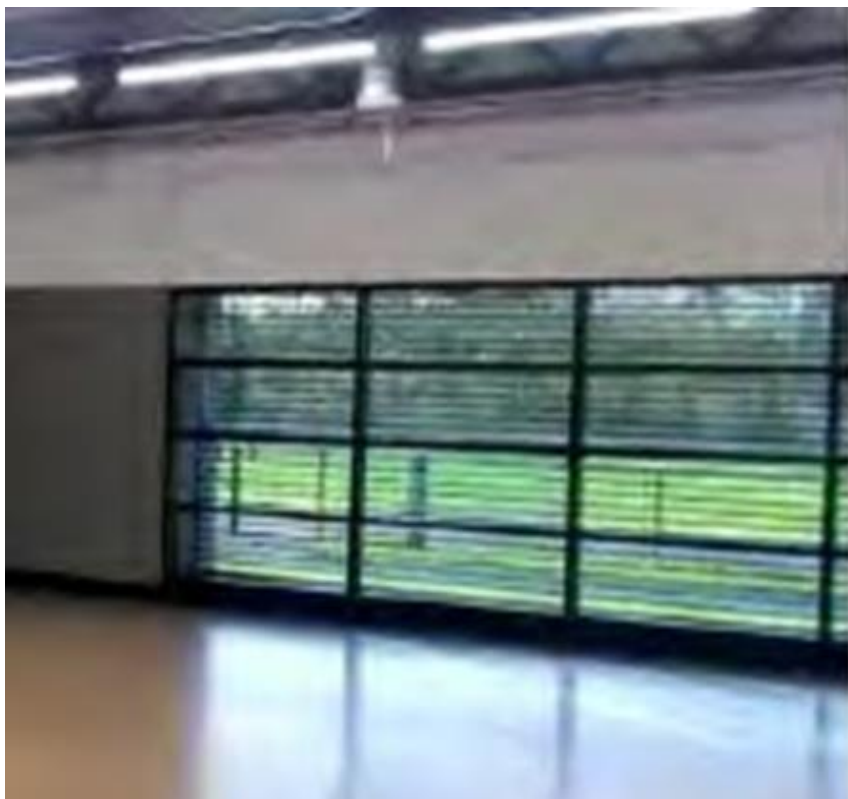
The windows in the usable areas of the building are double-glazed, there are single-glazed windows in the original part of the building with a wooden frame. This area houses the heating system, which generates a lot of secondary heat. This area should be monitored to see how the temperature is affected when the heating and hot water are turned on. If temperatures are high in the winter, then this excess heat could be diverted to another part of the building or recovered through a heat exchanger in the ventilation system.

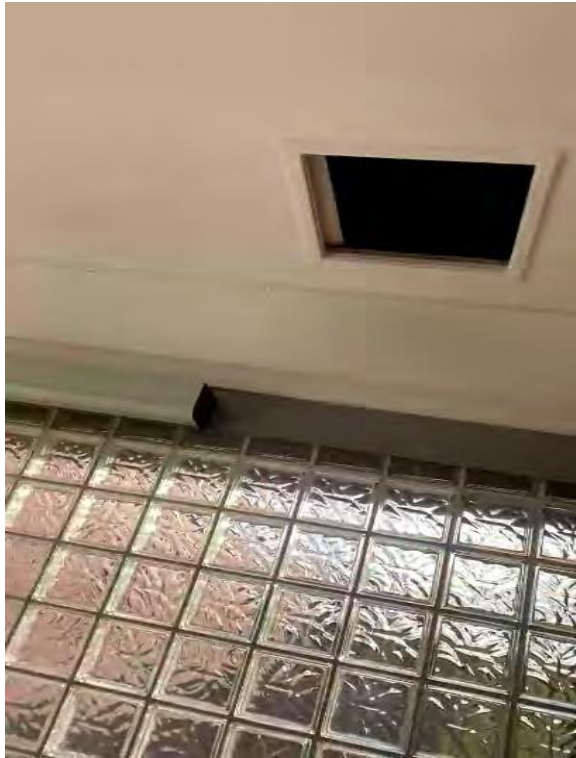
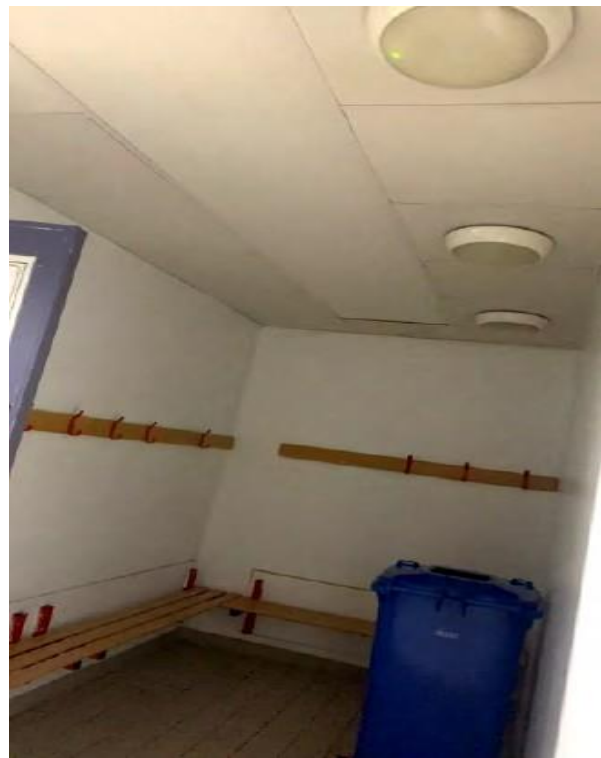
## Internal Roof Areas

There are some areas of the building which have an installed ceiling, this includes the entrance and the changing rooms. Adding insulation to these areas would have a benefit if the rooms were heated during the winter season or get too warm in the summer. The management would need to consider the preferred internal temperatures of these areas.

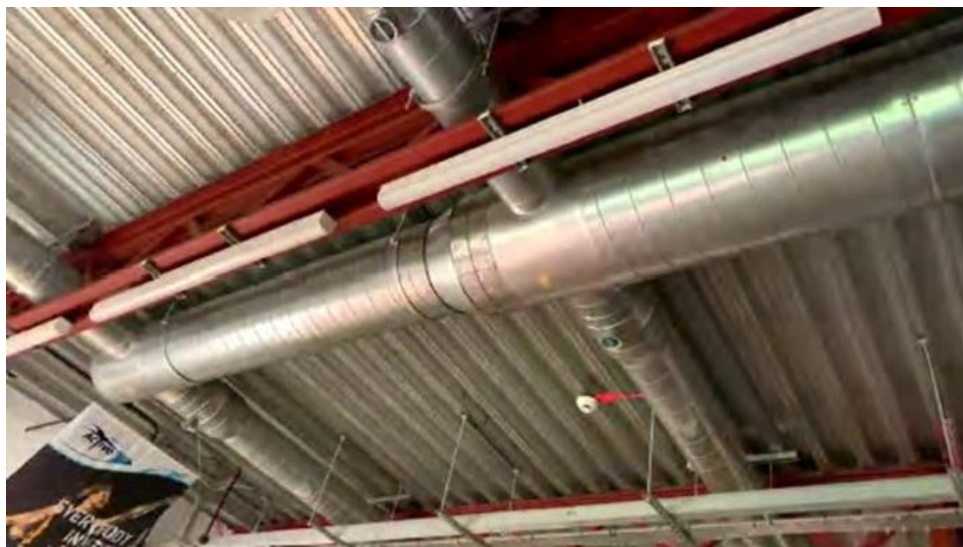
The exposed roof areas could be insulated, but the gains would be minimal due to the expected insulation value of the current roofing panels.

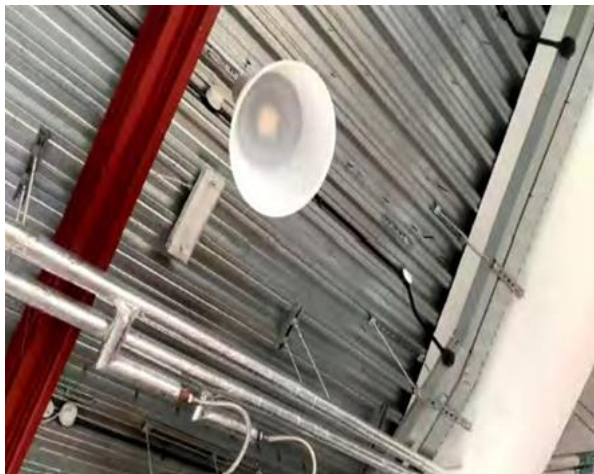
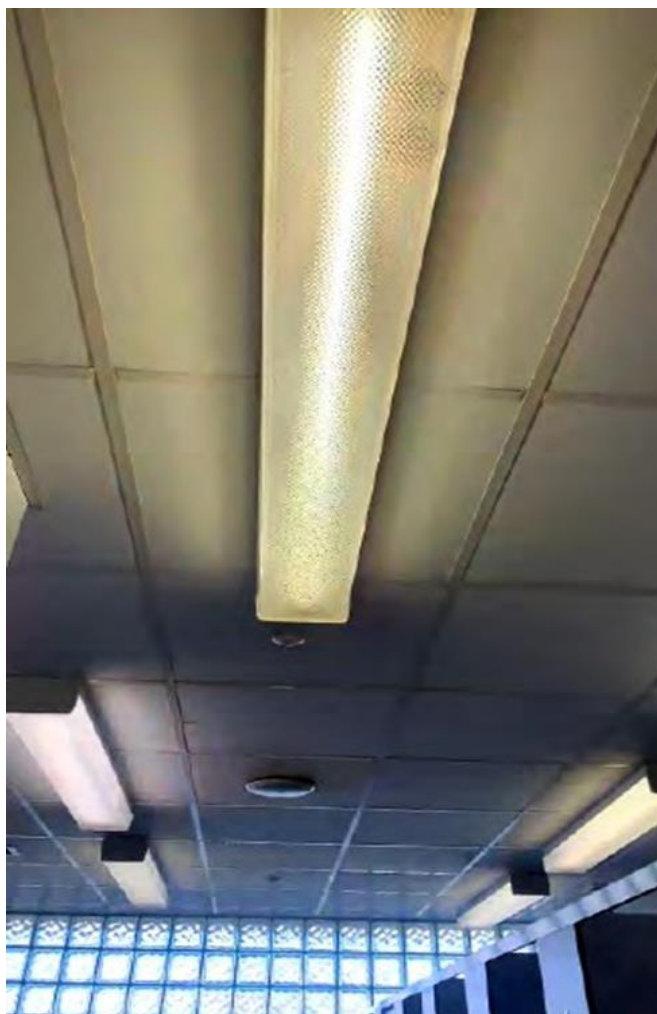
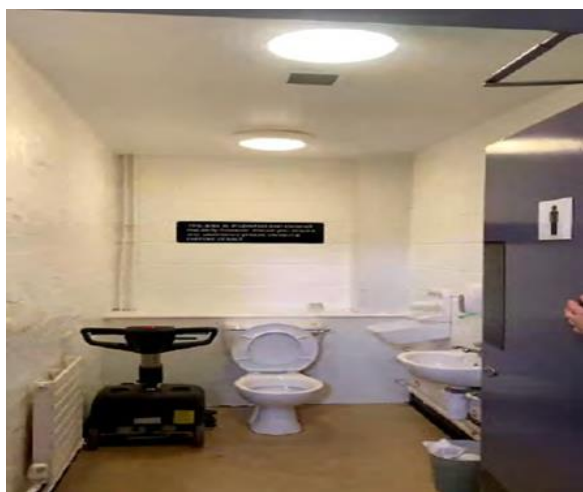
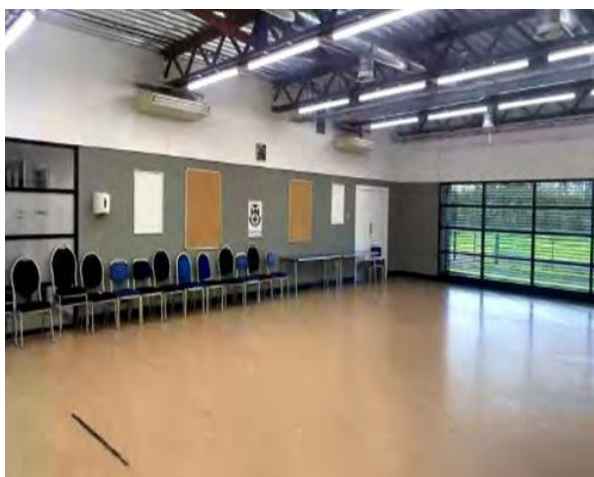
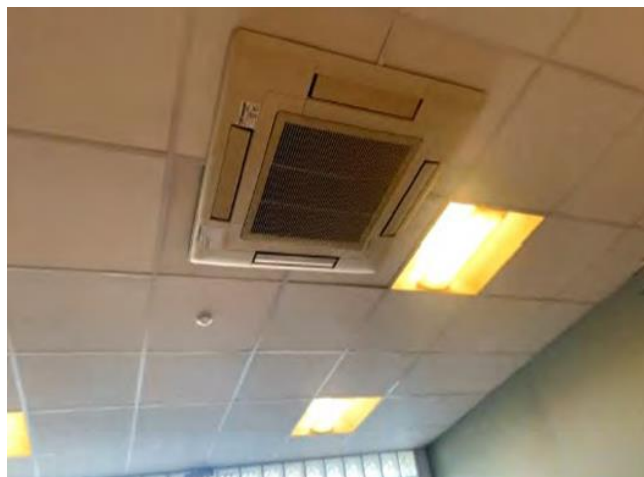
## Internal Lighting

The internal lighting is all low energy with a mix of LED, T5 Fluorescent and Compact fluorescent fittings. The lighting controls were manually operated. It would be worth considering additional signage to encourage users to turn the lights out after use or fitting motion detection sensors to operate the lighting automatically.

Lights should be replaced with a LED equivalent when they require replacing.

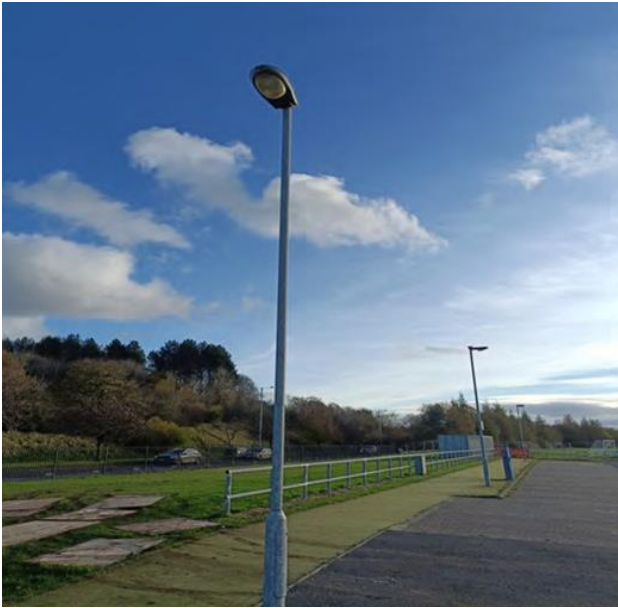
## External Lighting

The car park lights are on from dawn to dusk. This averages 12 hours per day over the year. Estimating the lights are 77w in consumption, the annual energy use is 3326kWh\*. Changing the controls for these lights to ensure they switch off when the building is closed at 10 pm would reduce the annual consumption to 600kWh\*. Thus, saving 2725kWh per annum.

Consider fitting a lux sensor with a timer to ensure lights are only on when required.

Consider replacing this with a suitable LED when lighting maintenance is required.

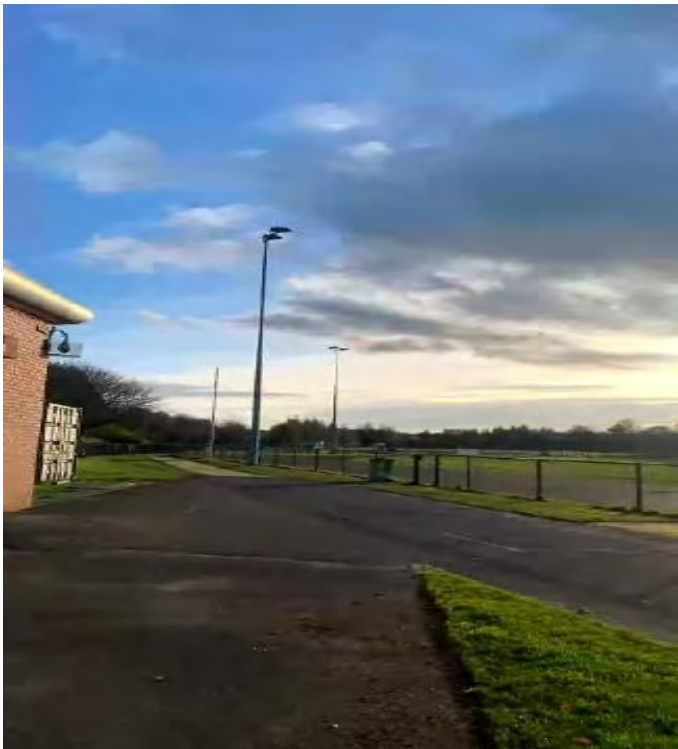
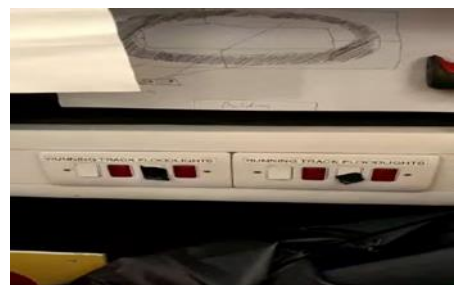
There is a proposal from Halliday Lighting to replace the external lighting around the track, 3G pitches and the 5-a-side pitches with LED. This would reduce the hourly consumption of all lights being on from 110kWh\* to 59.06kWh. If we estimate that the lights are on for an average of 1 hour per day, the annual saving is estimated at 18,338kWh\* per annum. (£4,320) per year.

3. Install LED externally.
4. Connect time switch and lux sensors to the external car park and boundary lights to minimise consumption.
5. Where lighting is switched ensure that switches have notifications to encourage building users to switch off when not in use.

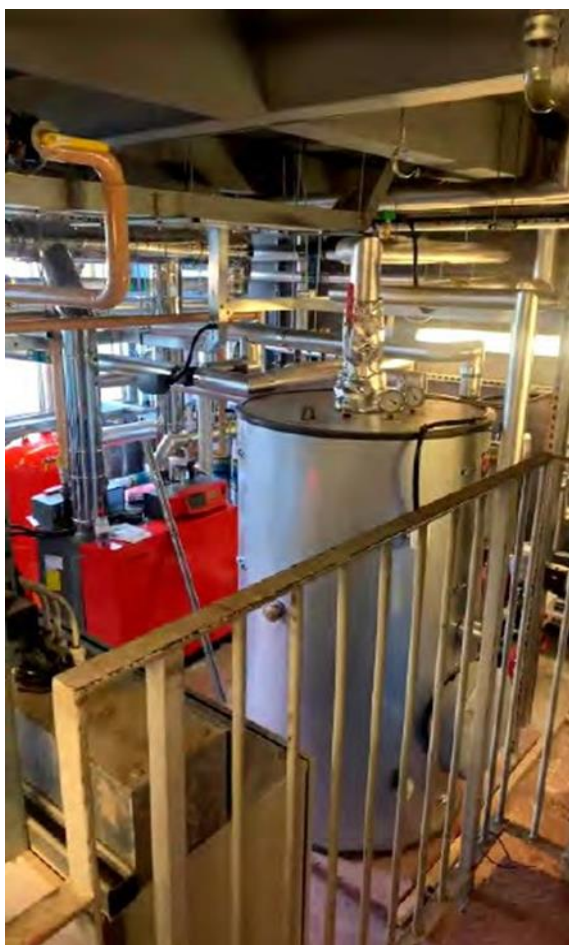
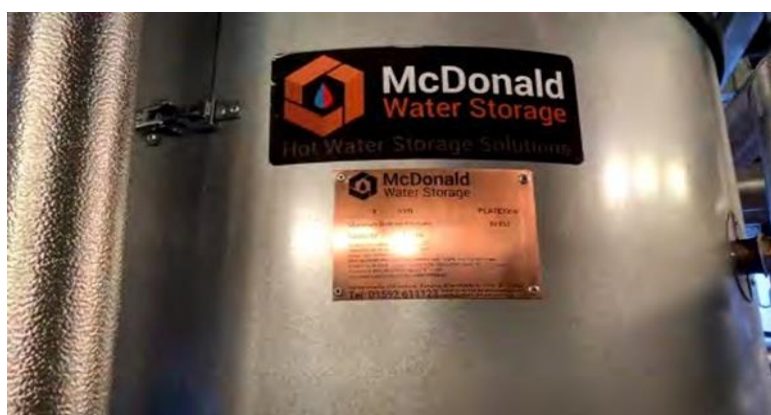
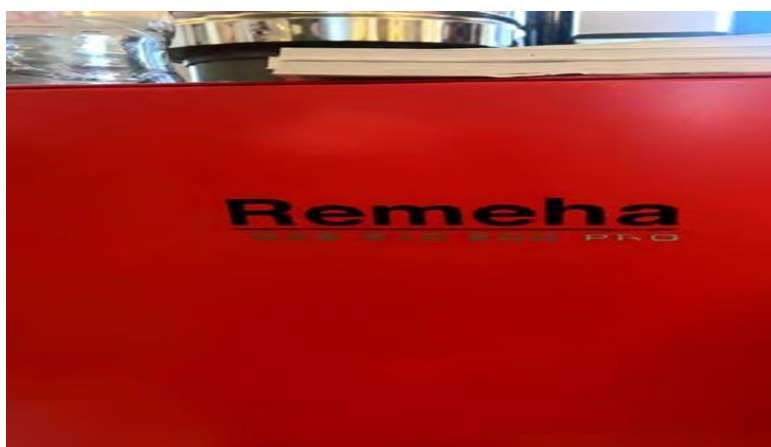
## Hot Water (Primary)

The Remeha 210 ECO PRO boiler has a seasonal efficiency of 95.8%.

The boiler provides both the heating and the hot water for the building. The gas consumption provided was for five months of the summer period with a total of 25,635kWh used. Estimating that this was for hot water use only, this is the equivalent of 3000 litres per day.

This main use for hot water is the showers and has an estimated output of 10 litres per minute. This would mean one shower was constantly on for 5 hours every day. It is difficult to determine if this figure is true as there are so many influencing factors. The timings for generating hot water should be investigated, as when the survey was taking place there was hot water available at the tap. This would suggest there was up to 500 litres of hot water available at 2 pm in the afternoon, even though it was unlikely to need this quantity until one hour after the pitches were opened.

There does need to be hot water provision for all building users when the building is open, but 500 litres is excessive and costs the organisation a lot of money.

The consumption of gas for hot water could be reduced by thinking about when the need for large amounts of hot water is required. At present, the 500l hot water tank is warm even when there is only 1 of the building users on site. Considering how the building is used and what would suffice as an adequate provision at this time will reduce costs.

1. Develop a green procurement plan for internal lighting and secondary electrical appliances.
2. Consider hot water use and identify the demand periods when it is appropriate to have 500l ready for delivery.

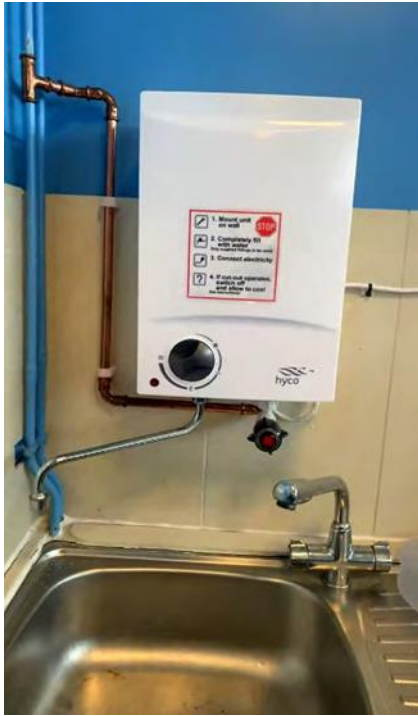
## Hot Water (Secondary)

While the boilers were not working, the unit was fitted with these point-of-use water heaters to provide hot water for the purpose of hand washing. Since the boilers started working these have become defunct.

It is worth considering installing point of use water heater in the sink area of each of the bathrooms for when the building has very low occupancy (outside pitch, or gym operating times). The primary hot water supply (Gas Boiler) can be timed to provide hot water when the occupancy or facility user numbers increase.

This should be discussed further with all staff and an agreement reached on the possible locations of the secondary hot water provision.

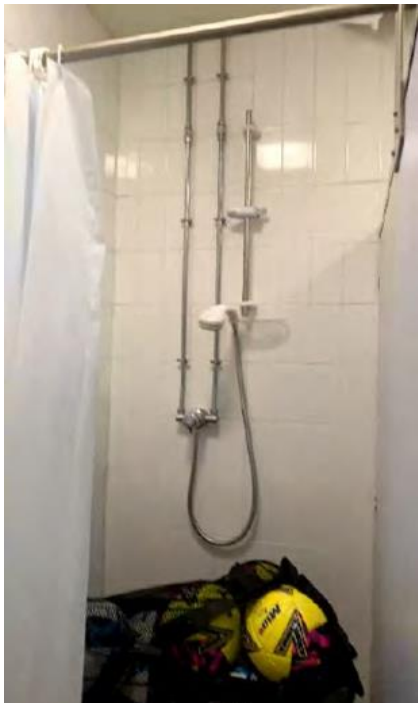
## Hot Water (Flow Rates)

Another way to reduce consumption is to investigate the current flow rates of showers and hot water taps and see if this can be reduced.

Taps can have a flow rate between 5 and 10 litres per minute. The lower the flow rate the less hot water is consumed. Showers can come in different flow rates as well.

Consider replacing shower heads and taps with reduced flow models.

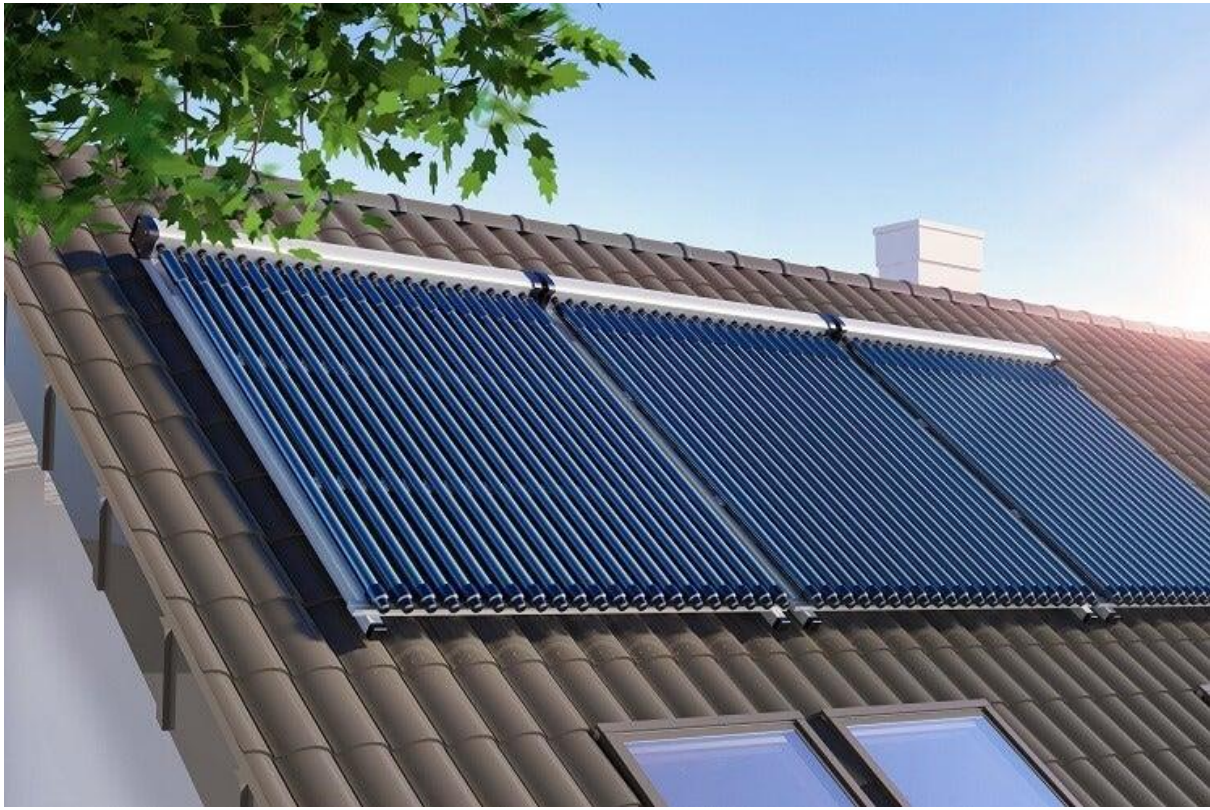
## Improvement Measure: Solar Thermal

One of the main costs facing the complex is hot water use, solar thermal should be considered as the building is not in use all day and the hot water requirement is in the evening. Having Solar Thermal installed would allow hot water to be generated all day and then be used in the evening. This would mean the existing boiler would only have to top up the temperature once the building came into use.

Further professional advice is required, but on average a 4m<sup>2</sup> evacuated tube installation could save an estimated 1,000kwh per year. The complex should consider a larger, more commercial installation. As this is essentially a decarbonisation of heat project there may be funding available through CARES.

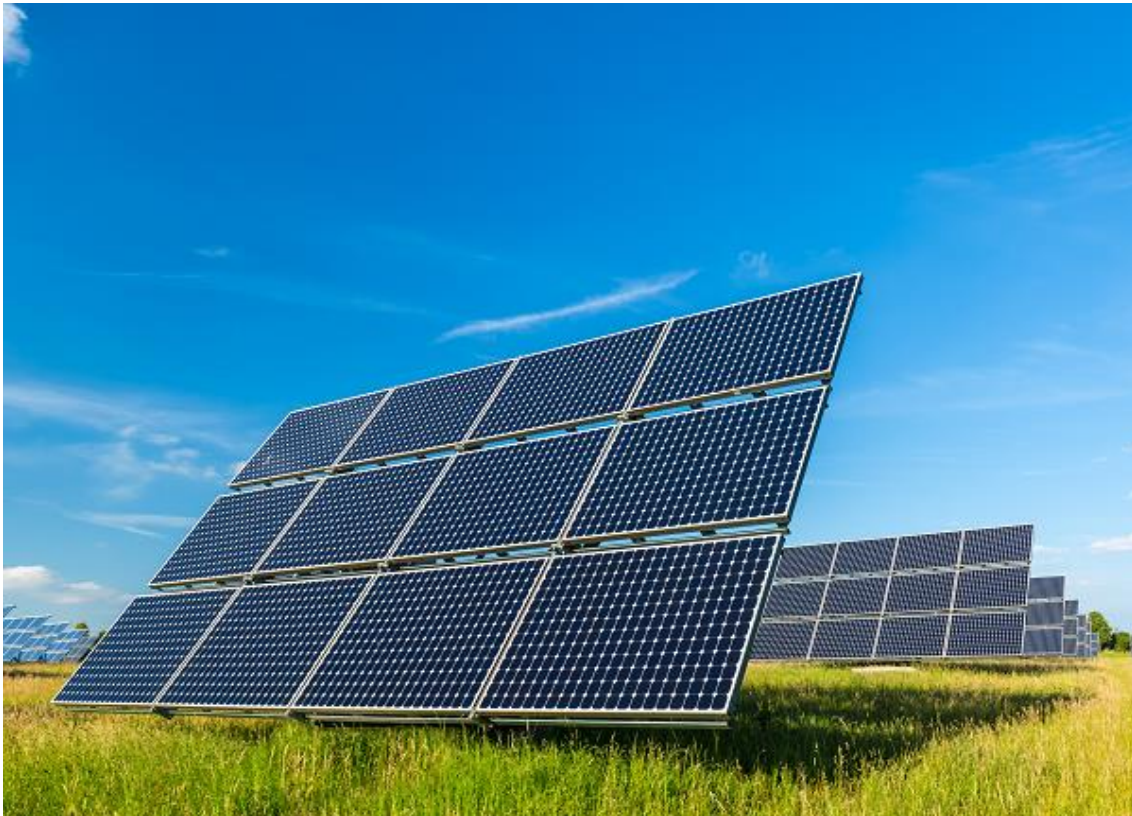
## Improvement Measure: Solar PV

Many organisations are considering installing Solar PV as an on-site micro-generation system. The complex is not suitable for a large solar array as most of the power consumption is currently in the late afternoon or early evening. This would mean a large percentage of the energy generated by such a system would be exported to the grid for a low tariff.

If solar was considered a small array (1,2 or 3kWp) that might be suitable to meet the daytime consumption rates, further investigation into this consumption would be required to match a system output with demand.

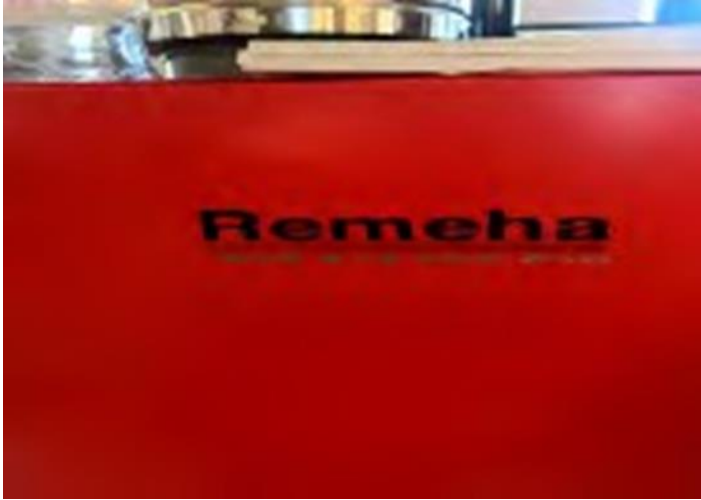
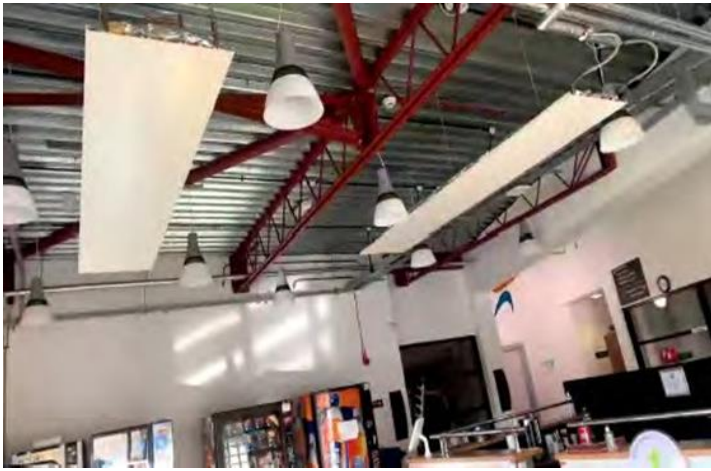
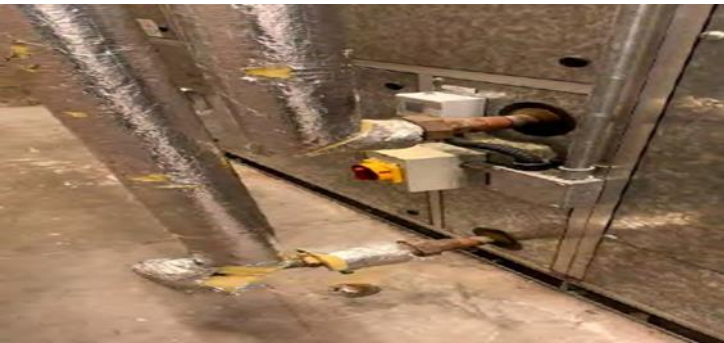
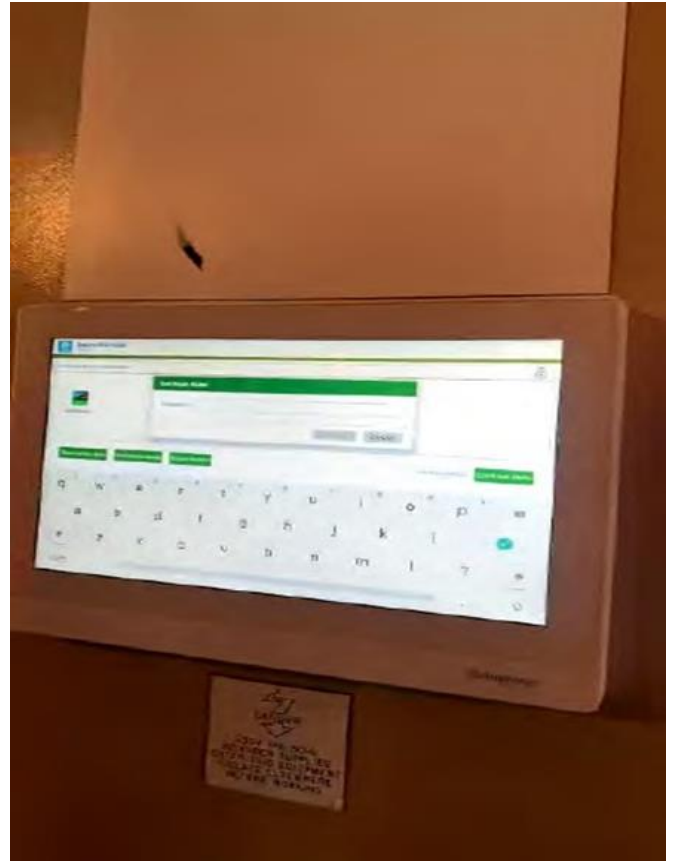
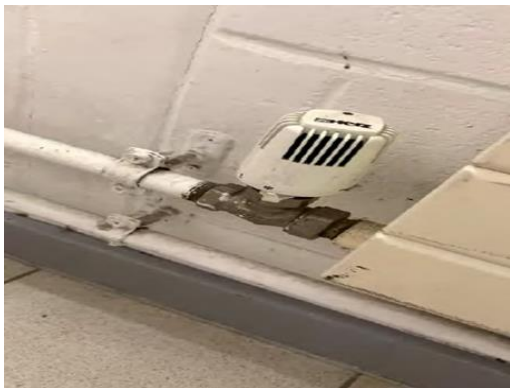
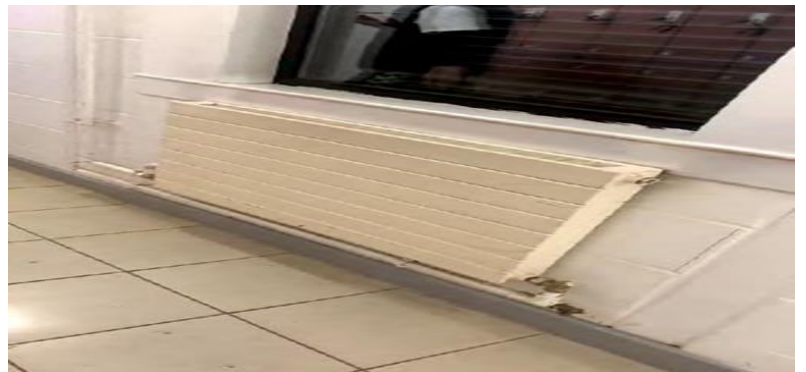
## Heating System

The primary heating system is from the Remeha Boiler, and this feeds the radiators, ceiling panels and the preheat/ heat to the ventilation system. The system is controlled by a BMS of which the instructions for use were not passed over to the current management.

Consider asking the BMS engineer to provide a demonstration on how to change the settings for the heating and ask for an updated list of the thermostats and weatherisation devices that are fitted to prevent the building from overheating.

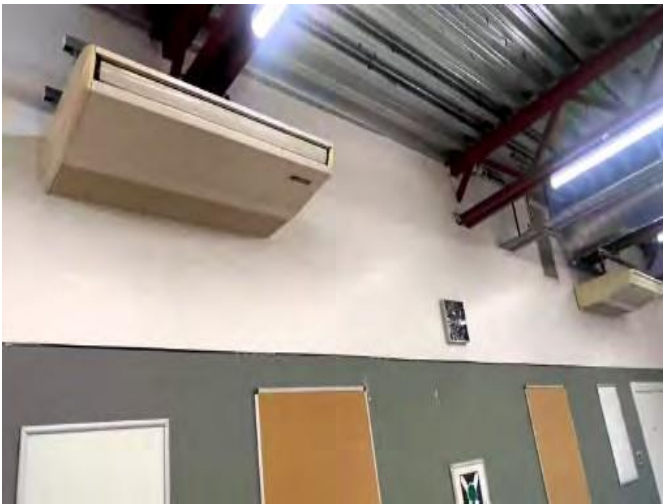
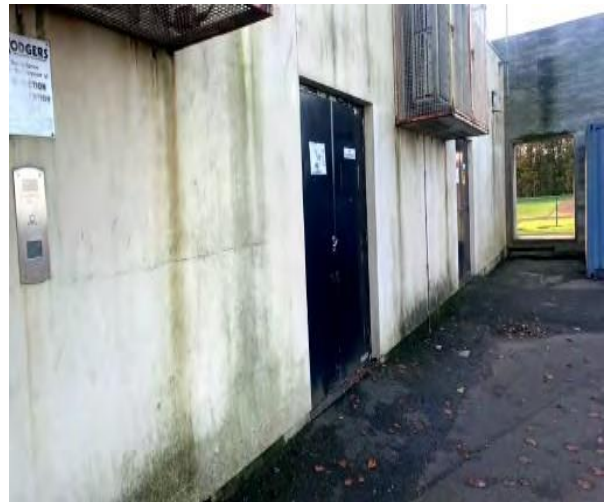
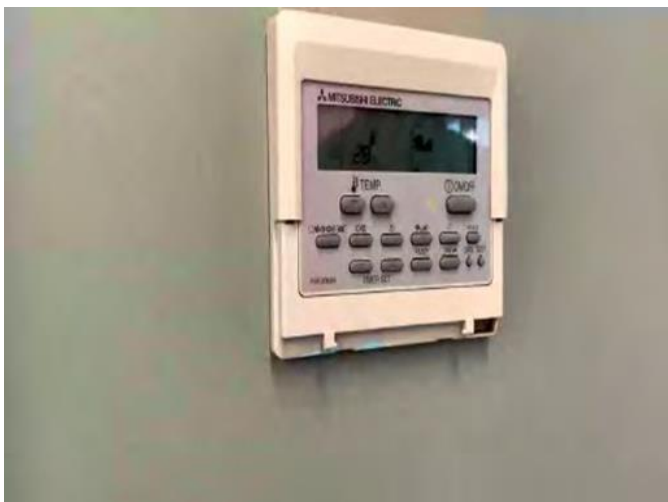
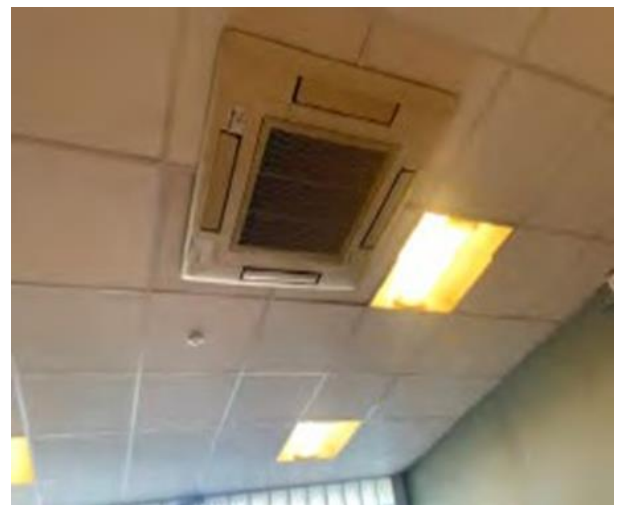
## Heating System (Air Conditioning)

The gym and the dance studio are fitted with air conditioning units, these are Mitsubishi air-to-air heat pumps which can also provide cooling. There are no gas-linked radiant heaters in these areas. At the time of the audit, these units had not been used as the gym was not open. It is hoped that these areas' use will increase, and we would expect the energy consumption to increase in line with this.

The temperature of these areas should be set much lower as activity will be taking place and therefore settings of 20 degrees are not required. Make sure and use the settings for air conditioning to either heat or cool to avoid the room being heated and cooled on the same day.

Consider replacing with the most efficient unit when the life cycle of the current units is reached. Ensure that there are good maintenance plans in place as low gas levels will increase energy consumption.
